Montana Department of Transportation
Research Program
February 2002

RESEARCH CONSTRUCTION REPORT

Thin-Whitetopping Overlay Composite

Project No.: STPP 20-1(6)0 P-20, Highway 16

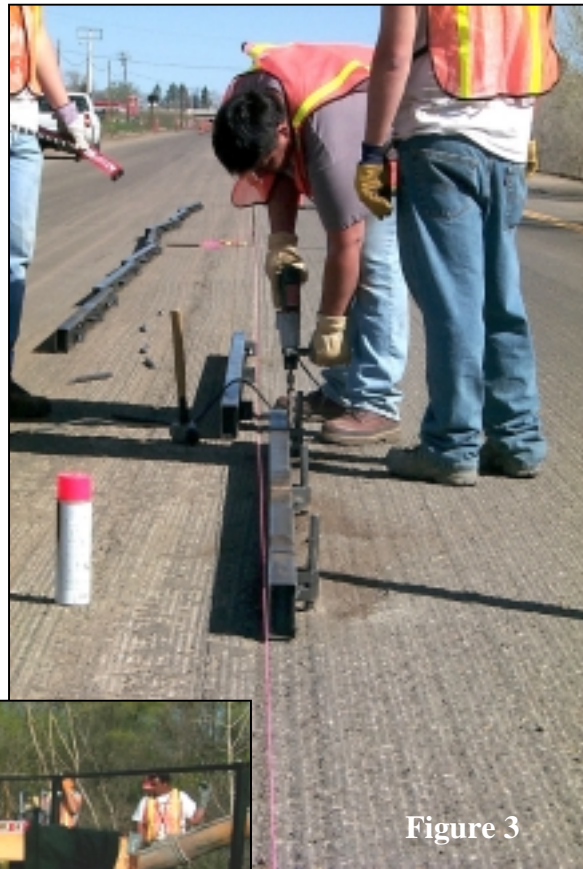
the PCCP layer. Workers drilled into the surface far enough so they were able to hammer the metal stakes firmly into the ground in which the steel forms (or rails) will be attached. Figure 3 shows the installation of the metal forms.

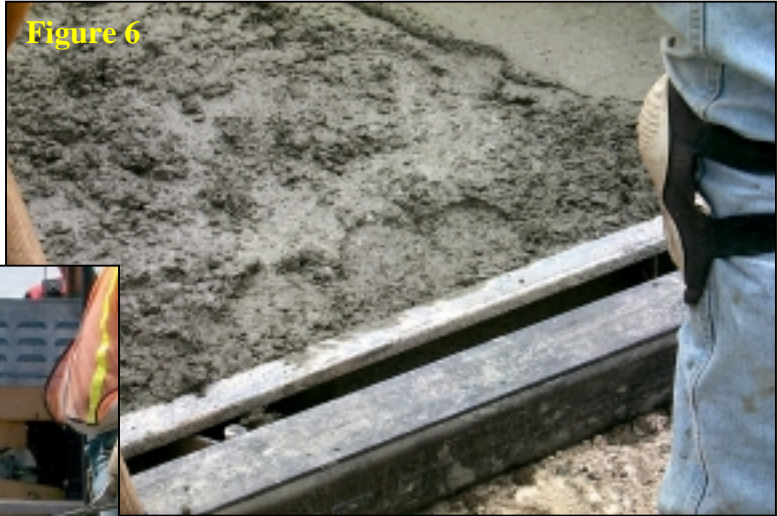
This was also placed beside the original metal forms. Figure 6 shows the metal form set-up and figure 7 illustrates how the wood was used.. This procedure was used for the southbound lane of the project. The northbound lane used the double form scenario on the right side of the lane only. The flat metal stock was laid atop the left side of the southbound whitetop lane. This allowed the tube roller to set on the PCCP layer without damage during the paving process. Figure 8 is an overview of the paving process. Note the two virbrators (or stingers, shown by

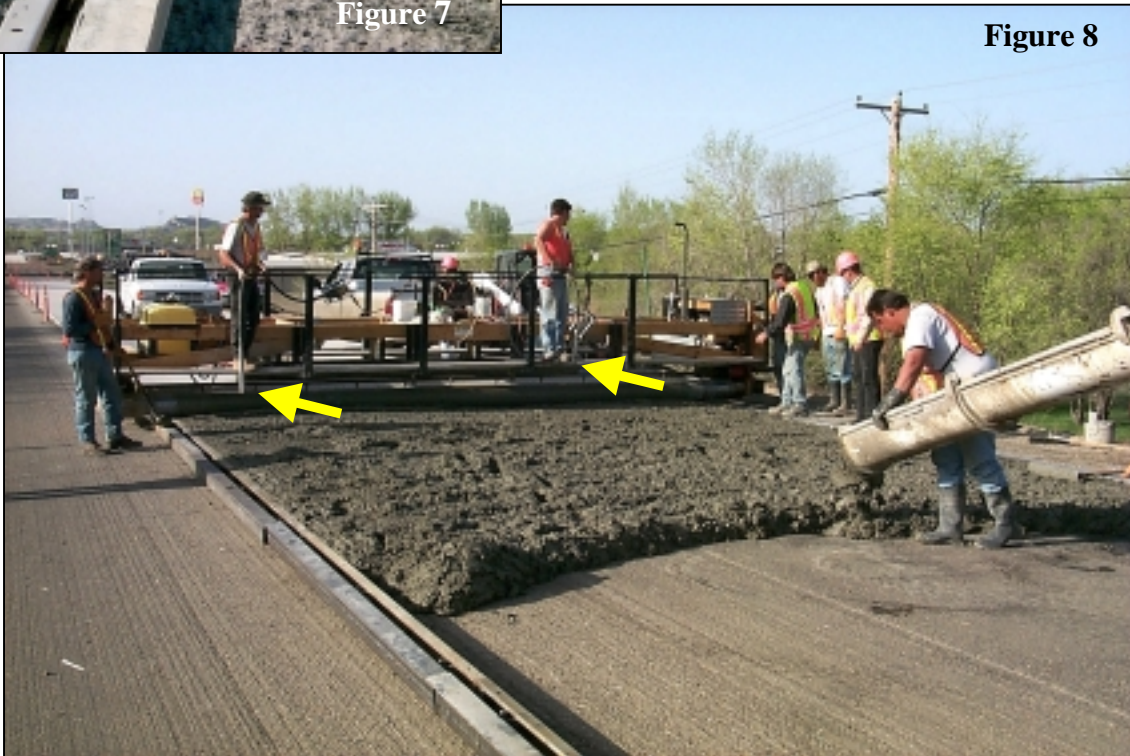
Figure 8

yellow arrows) being used to consolidate the concrete. The contractor did a good job in pacing the consolidation with the speed of the paving. Once the concrete was placed, curing compound was applied to prevent premature curing. Figure 9 shows Greg Miller of Holcim Inc. (formerly Holnam) instructing the contractor on the correct application of compound on the finished concrete. Figure 10 is how the contractor was applying the cure the following day. There were noticeable gaps in coverage. It was difficult to impress upon the contractor the critical aspect of applying adequate cover to the fresh concrete. A special provision had even specified a double shot to insure sufficient coverage. This procedure was discussed in several meetings with the contractor prior to and during the start of the project. This may result in premature cracking and reduce the

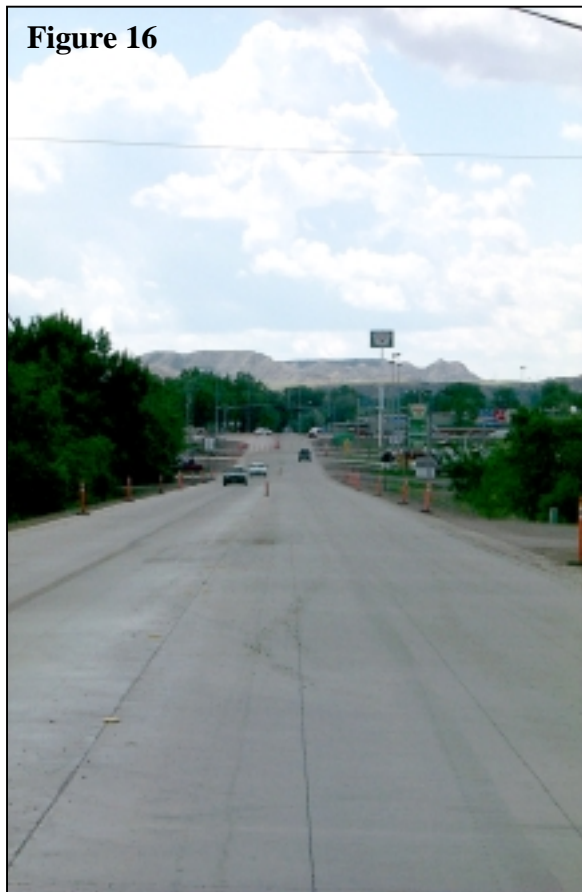
Figure 16 is an overview of the north and southbound lanes completed prior to striping. The first annual evaluation will be held in the summer of 2002. This formal evaluation period will encompass five years with an additional informal evaluation period which may last up to an additional five years.
